Wind Turbine Gearbox Reliability

The Nature of the Problem

by Don McVittie

GEAR ENGINEERS, INC.
PO BOX 71327 SEATTLE, WA 98127

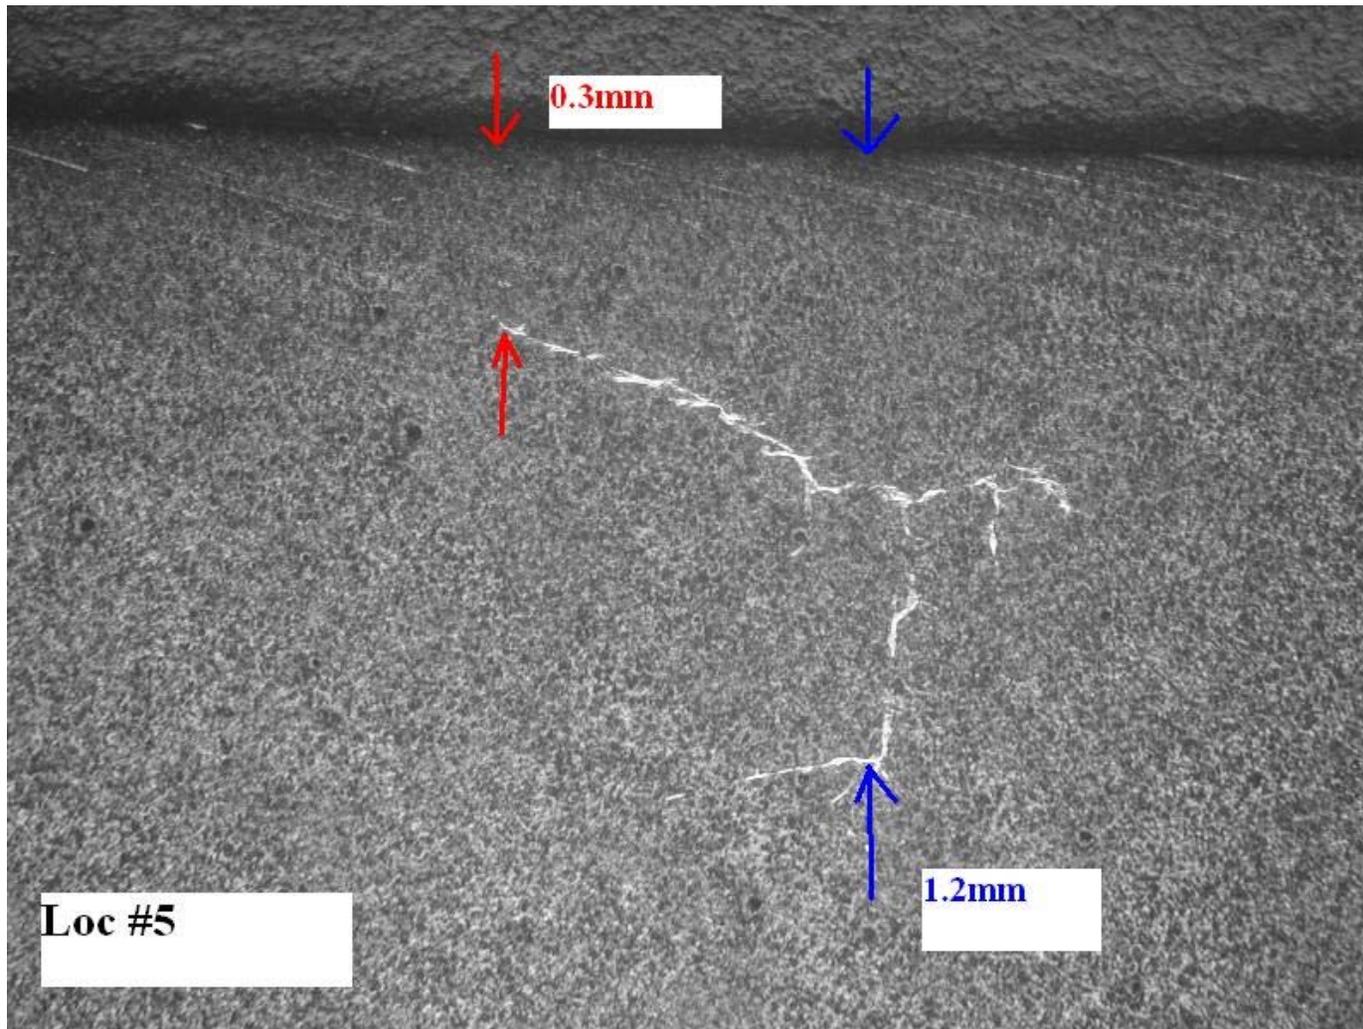
- No manufacturing defects
- Signs of overstress
 - Deep white etching areas, “butterflies” below the expected depth of maximum stress
 - Changes in surface compressive stress due to heavy rolling contact
- Debris denting
- Surface distress and lubrication effects

Butterfly micrograph – wind turbine bearing

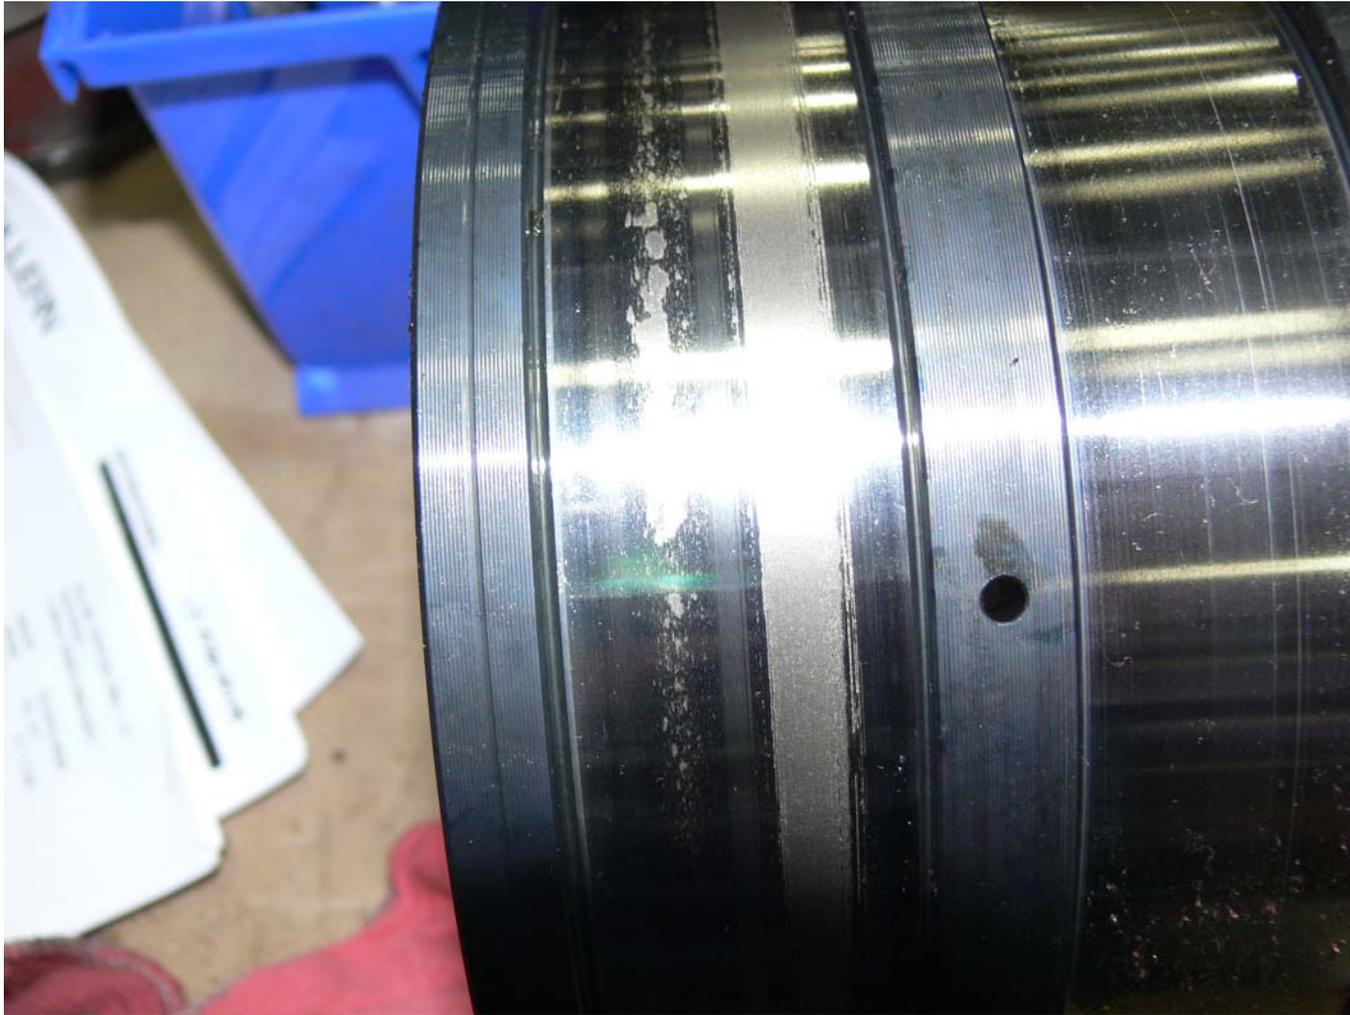
Planet bearing after 40,000 hours
