# **MANAGING THE FLEET**

**600 kw to 800 kw Turbines**

**Presented by: Dean Landon  
Caithness Energy**

## Gearboxes

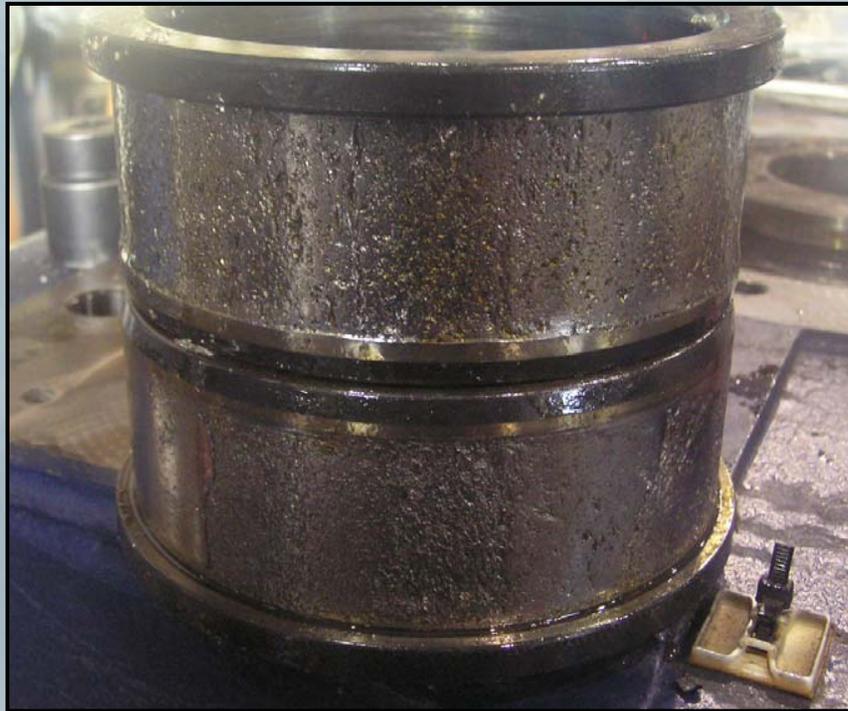
# Hansen EH55 Failure Mode

Planet bearing failure

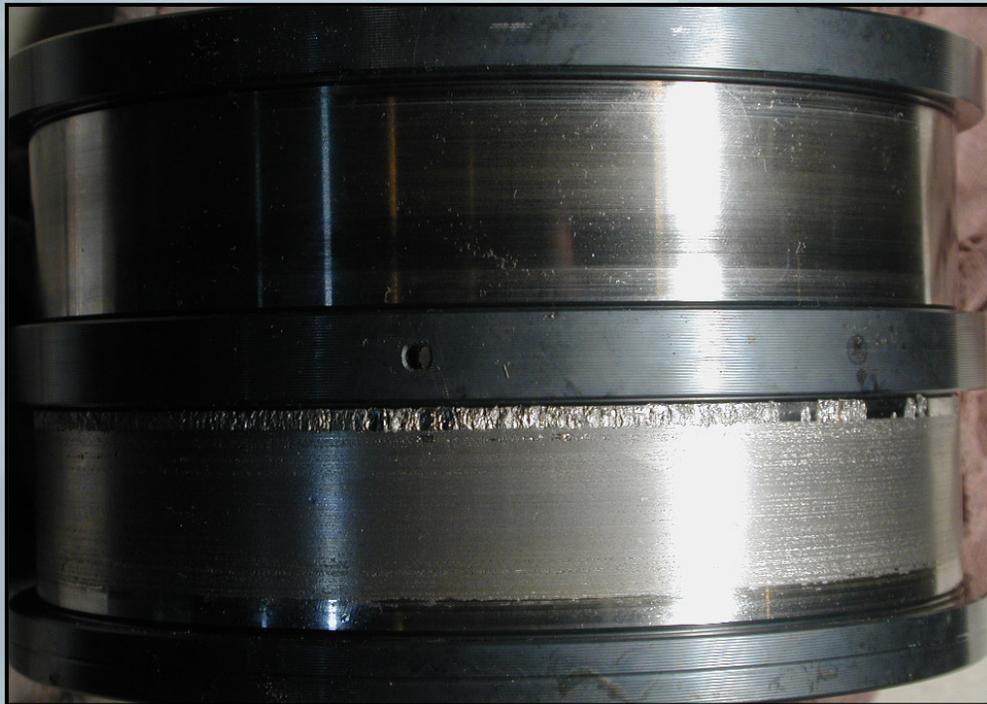
# Flender PEAC 4300 Failure Mode

Micropitting and macropitting of inner race of planet bearing

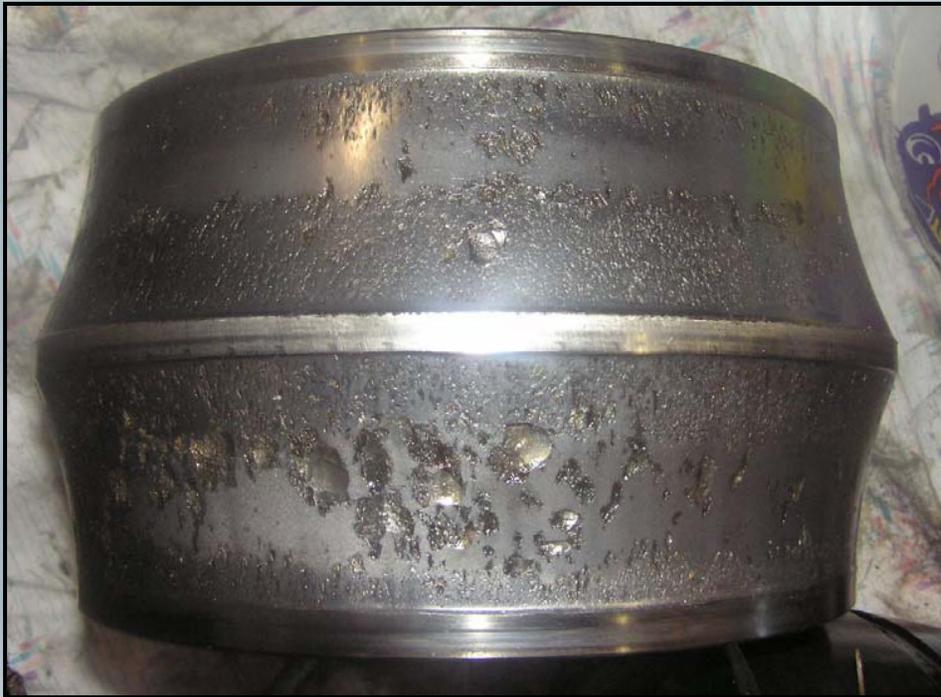
# Hansen EH552 Failure Mode

Planet bearing failure

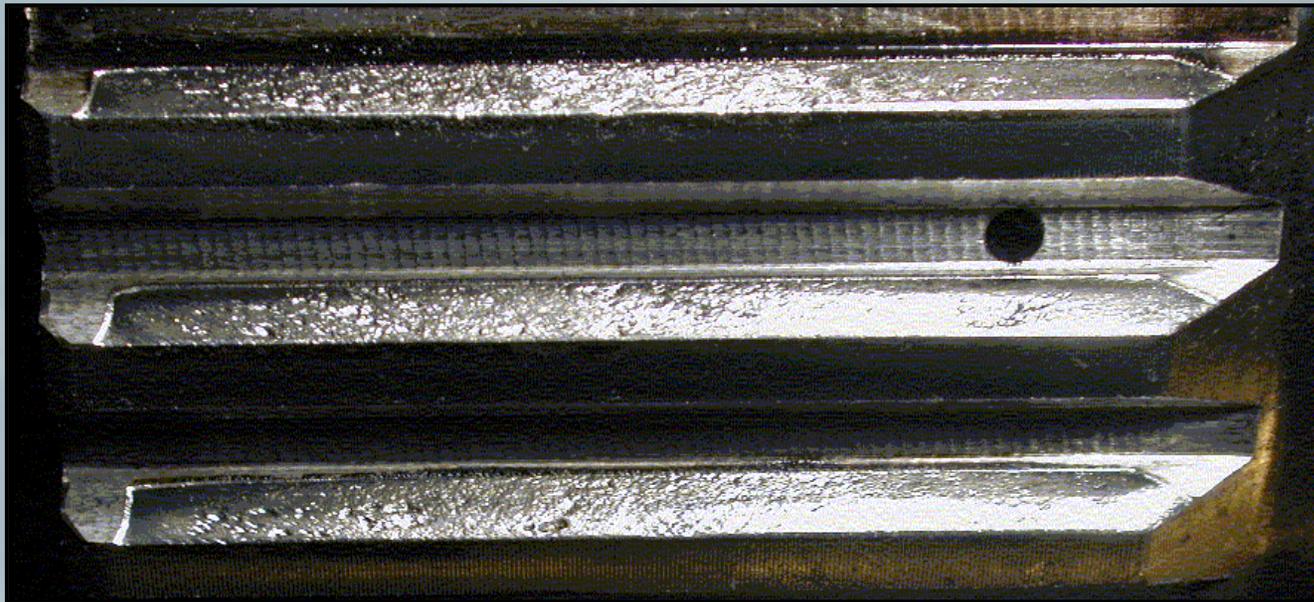
**Sun Ext Spline**

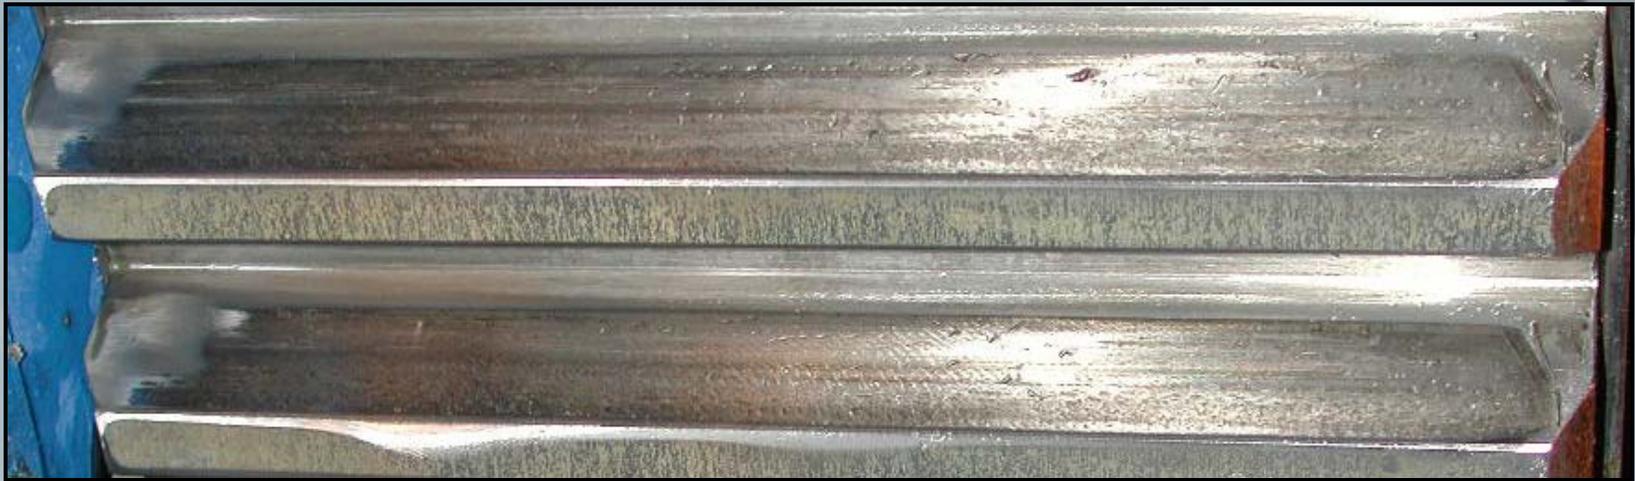
Ring DF at 6

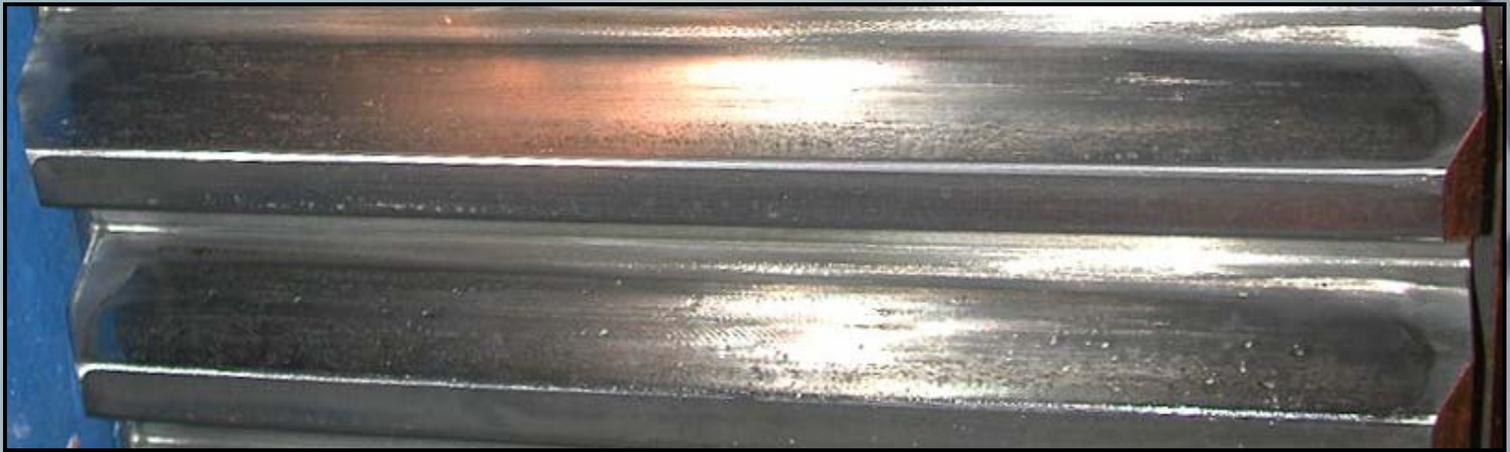
Ring DF at 12

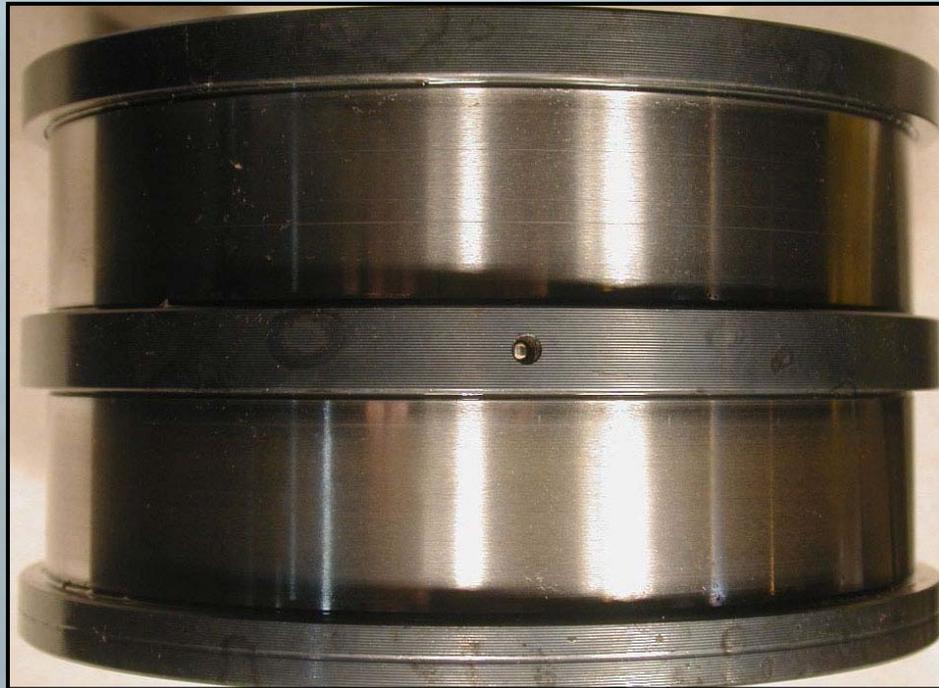
**IG Inner OD**

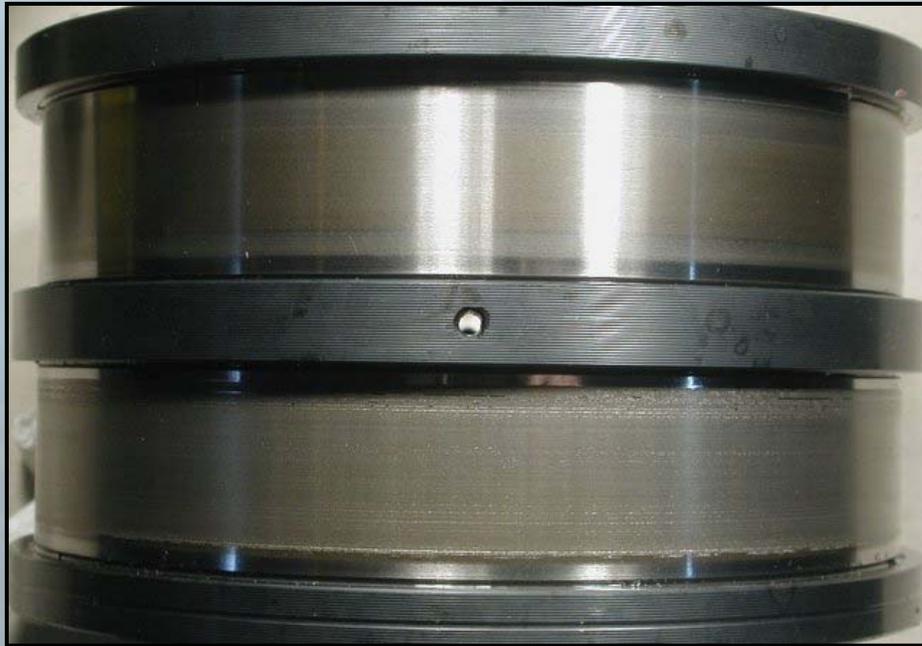
**IR Inner Race OD**

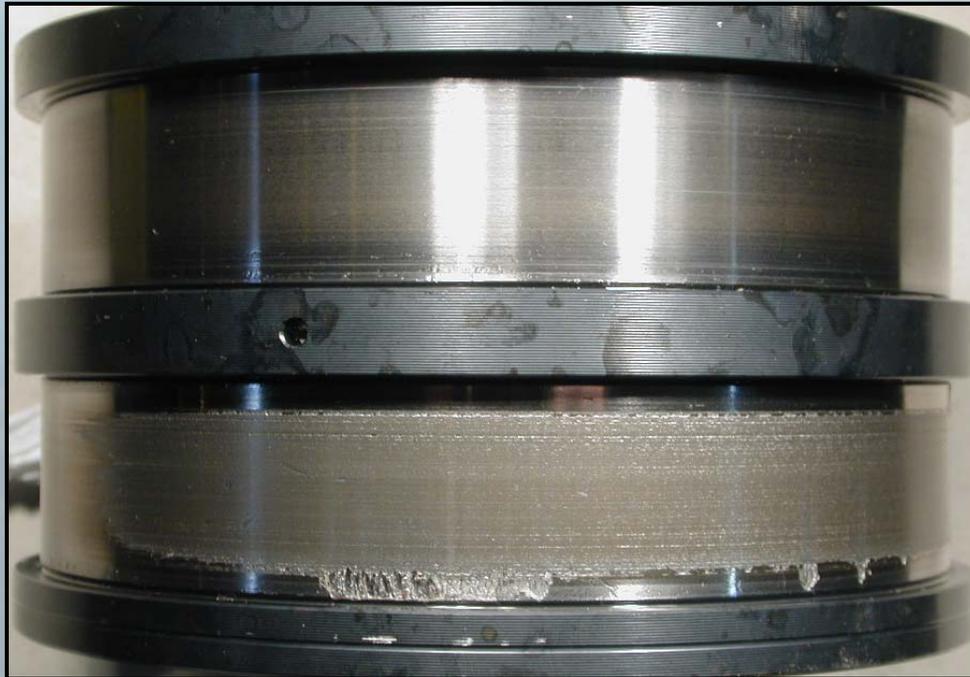
**2R Inner Race OD**

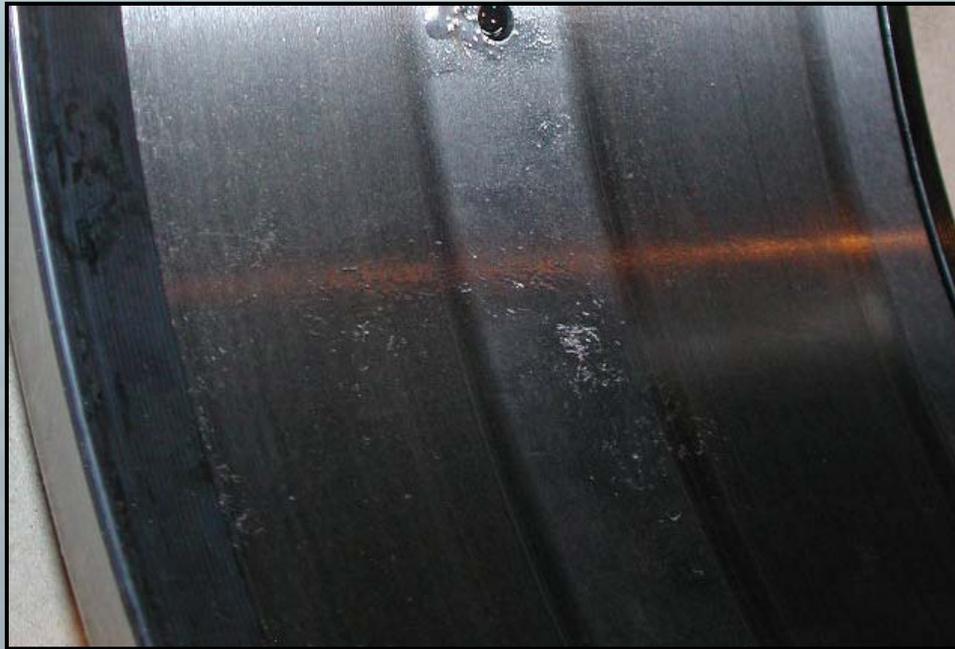
**2G Outer Race OD**

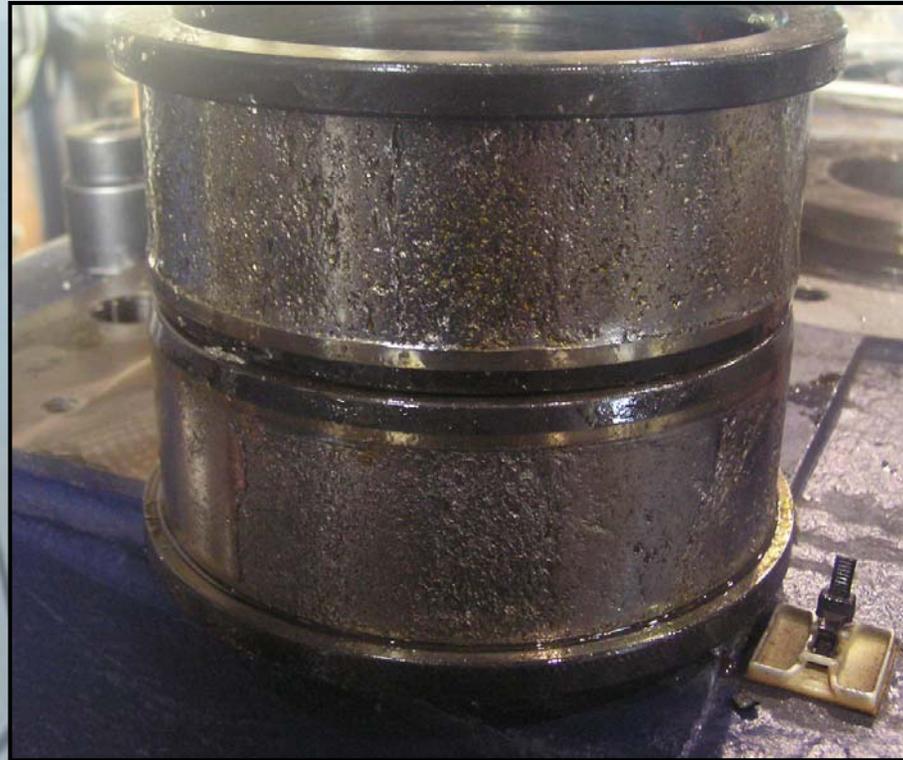
**Inter-race Plant Bearing**

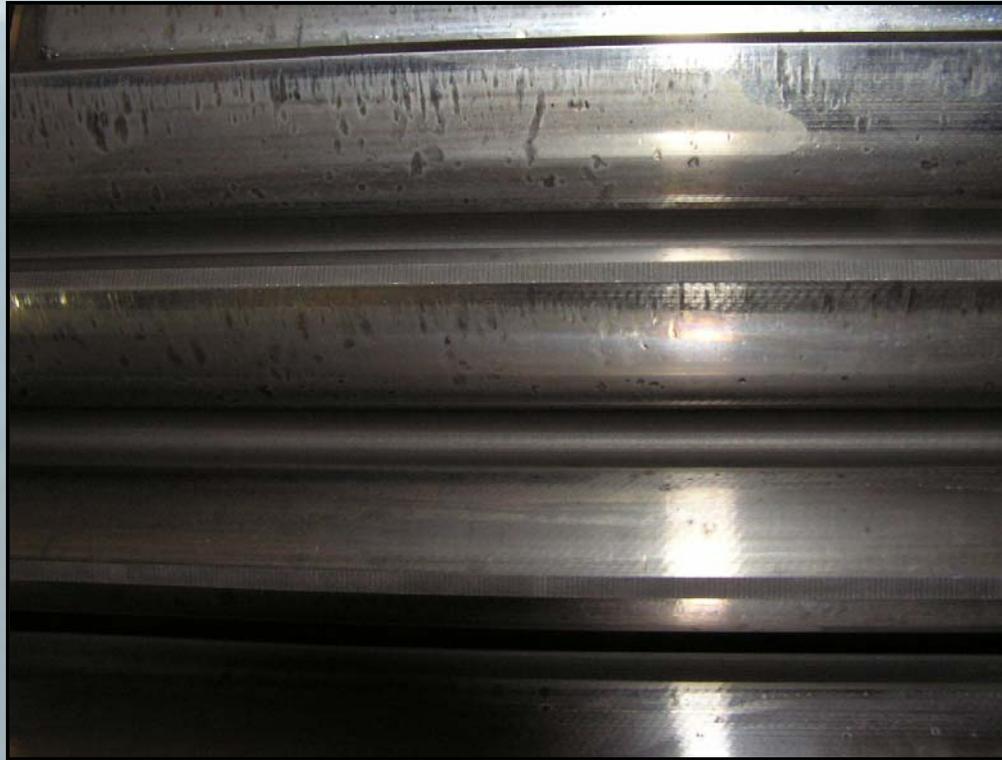
Plant Gear

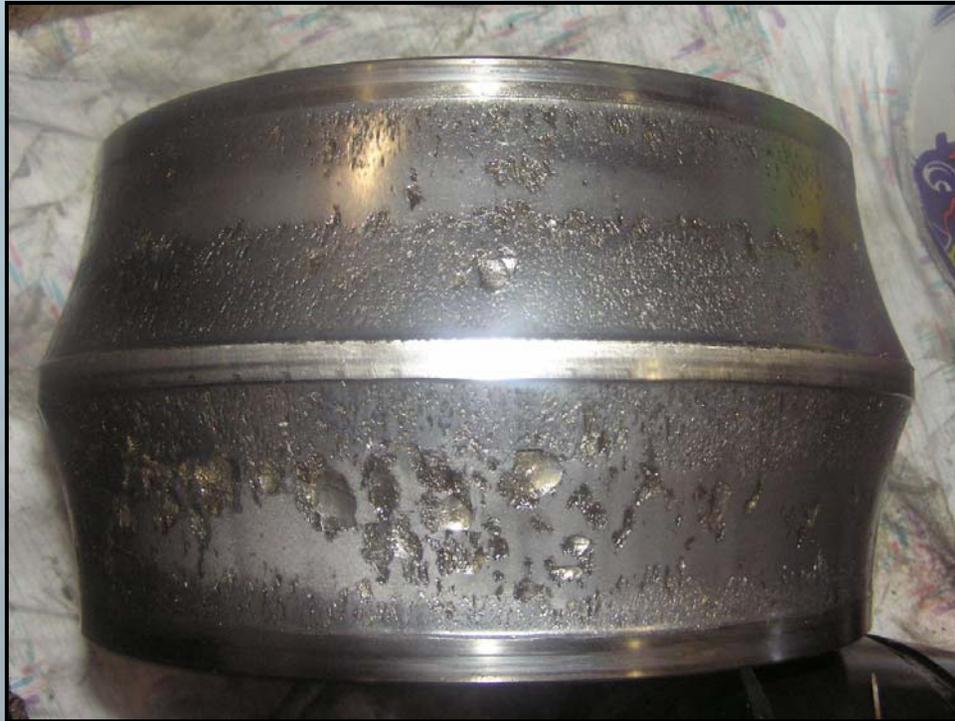
**Inter-race Plant Bearing**

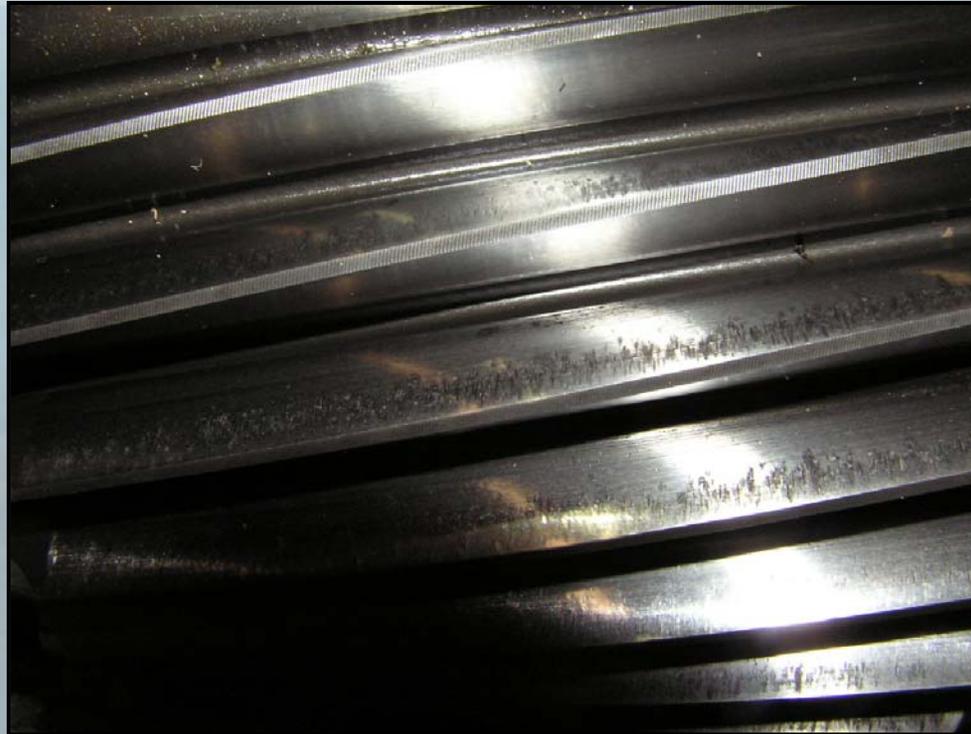
Planet Gear

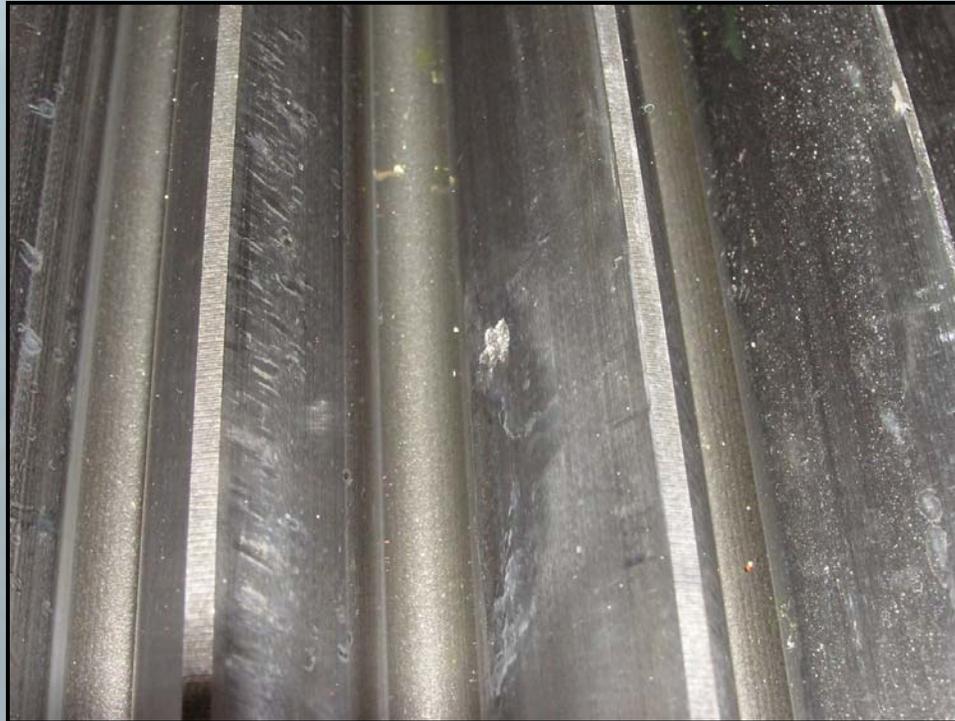
**Planet Gear**

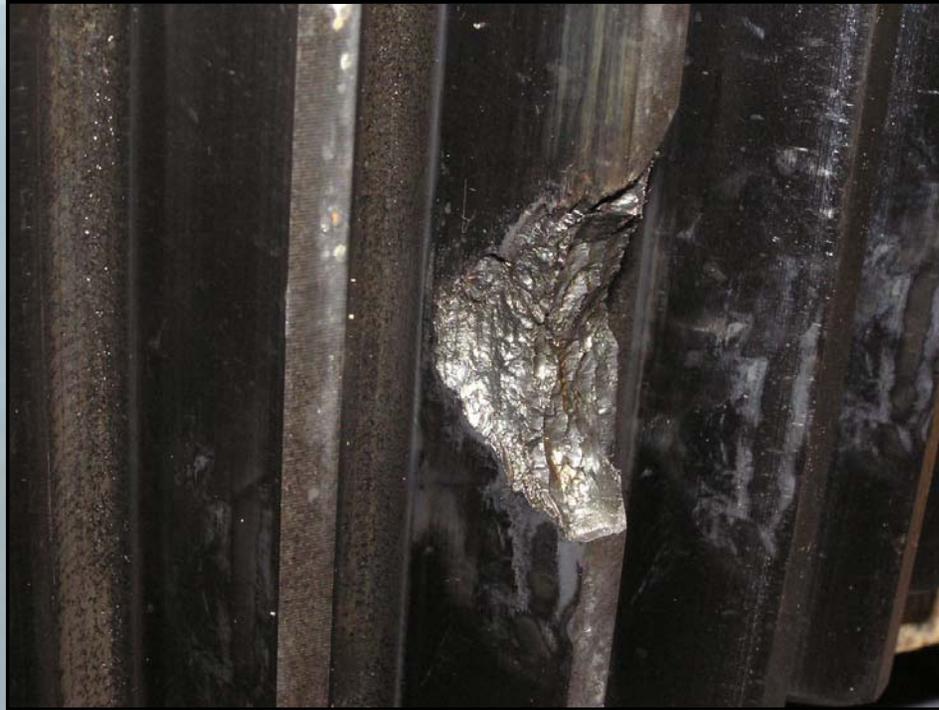
Ring Gear

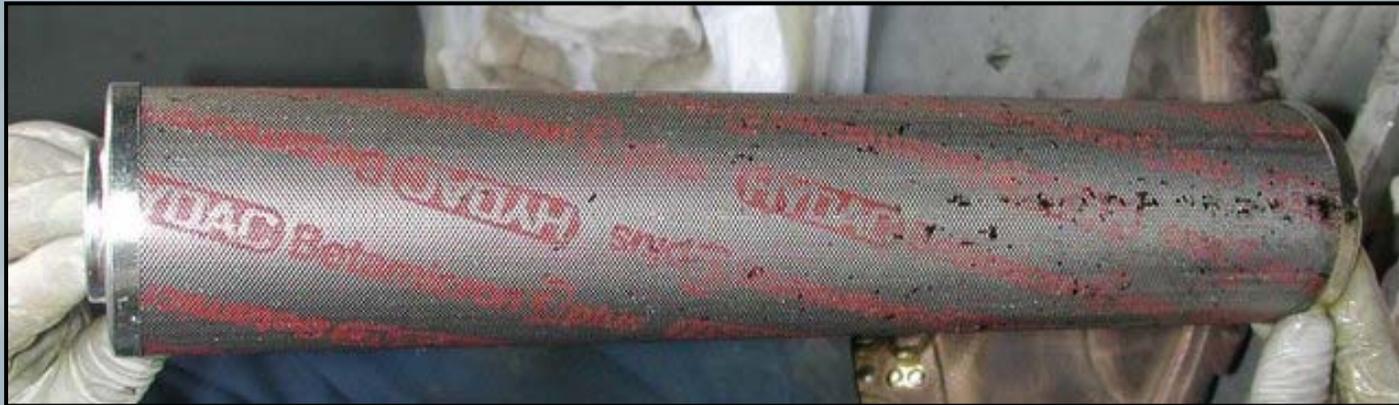
Filter inspection

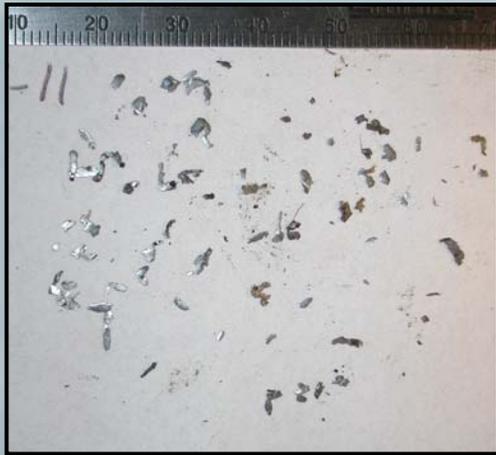
Filter debris

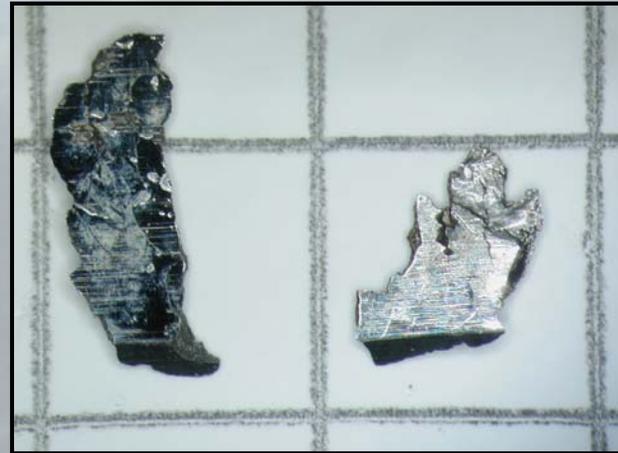
Spalling chips from  
inner race of planet  
bearing

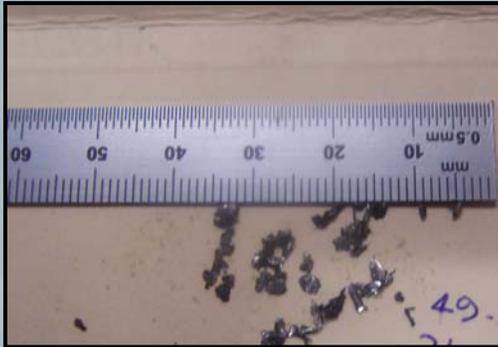
Filter debris

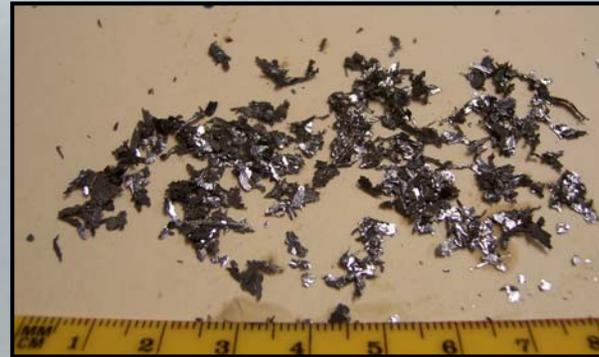
Filter Debris
