# Two Keys of Reliability Initiatives – Clean Oil and Oil Condition

Justin Stover  
C.C. Jensen, Inc.  
[justin@ccjensen.com](mailto:justin@ccjensen.com)

**2009 Wind Turbine Reliability Workshop**

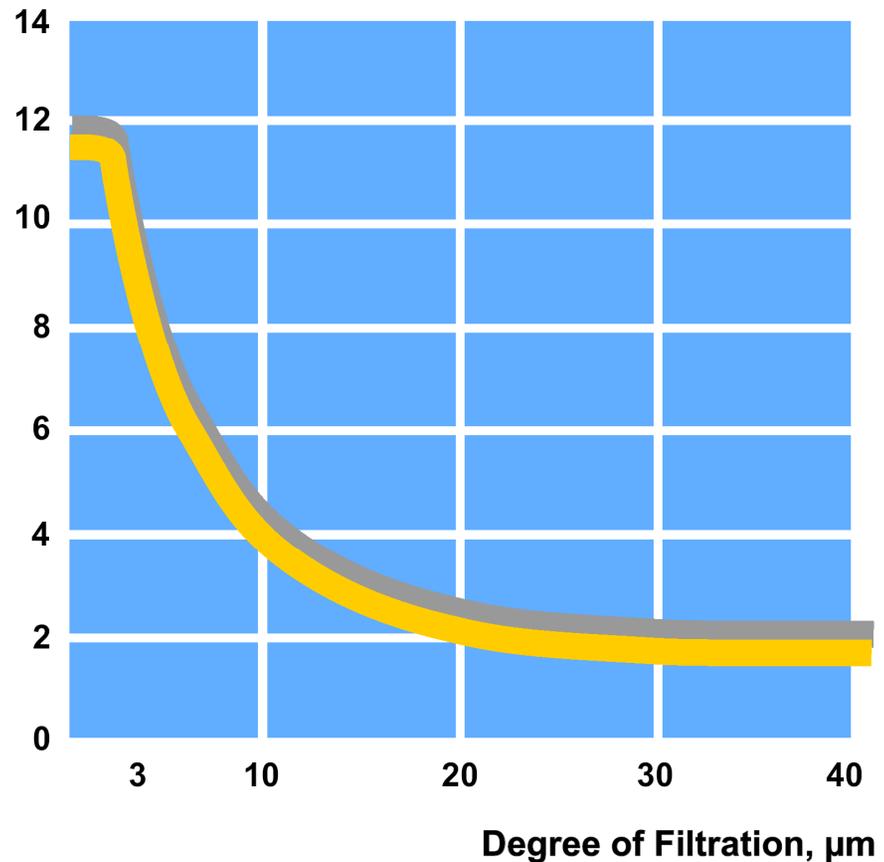
# Macpherson Curve

Researchers from London's Imperial College, Sayles and Macpherson, showed gearbox life can be increased up to seven times by changing from a 40 micron filter to a 3 micron filter.

Testing period,  $10^6$  revs

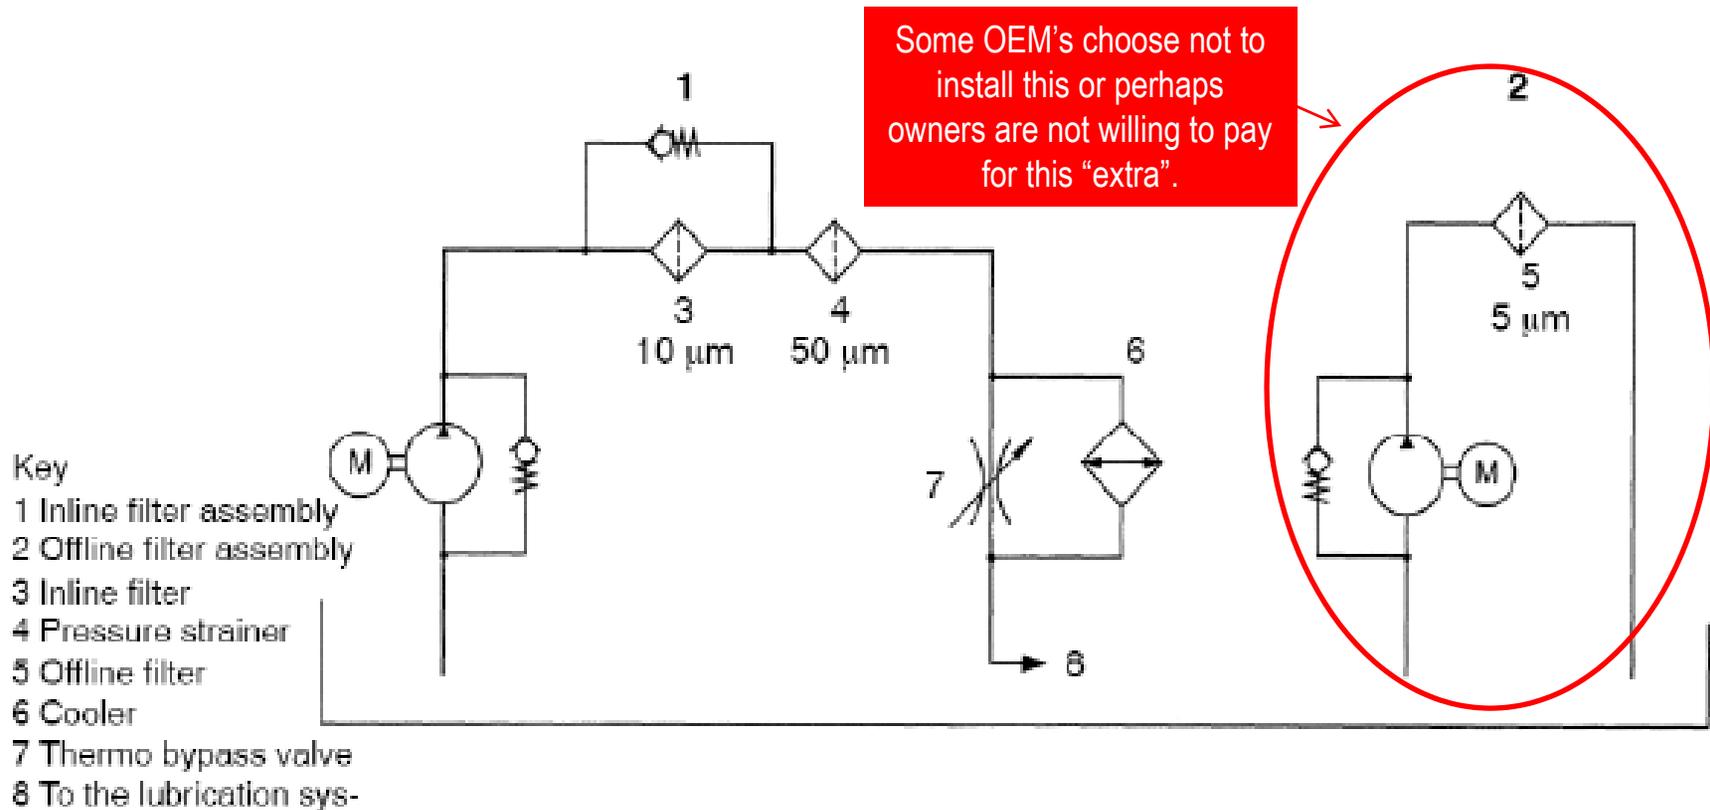
# Configuration of Filtration System

Ref:

ISO 81400-4 Wind Turbines Part 4: Design and Specification of Gearboxes

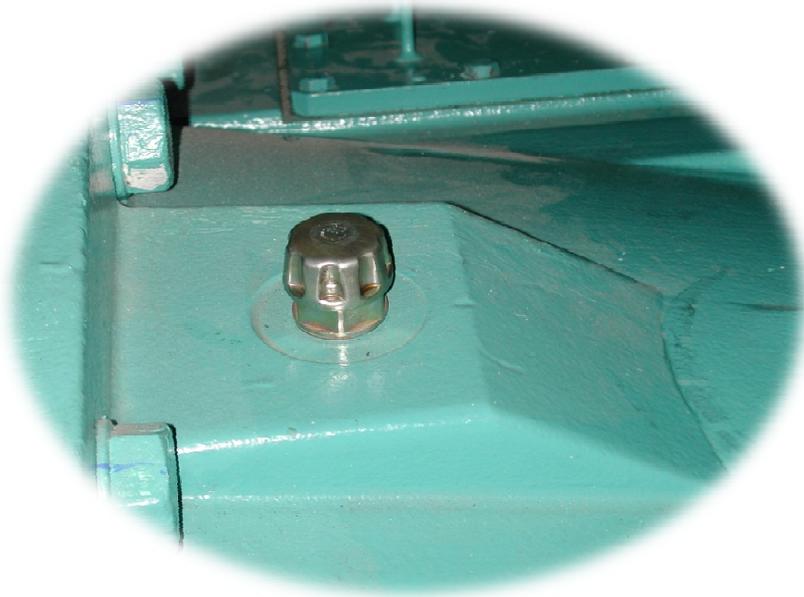
Old School

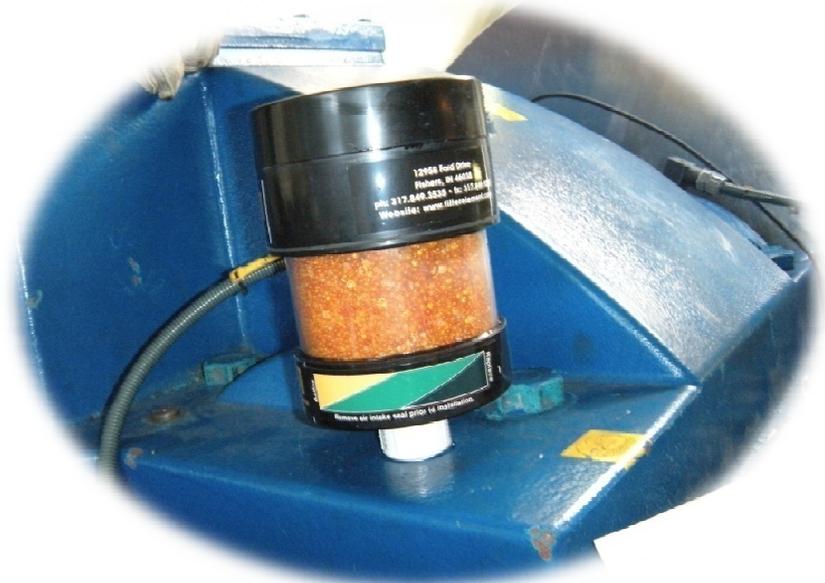
High Quality  
Desiccant Type

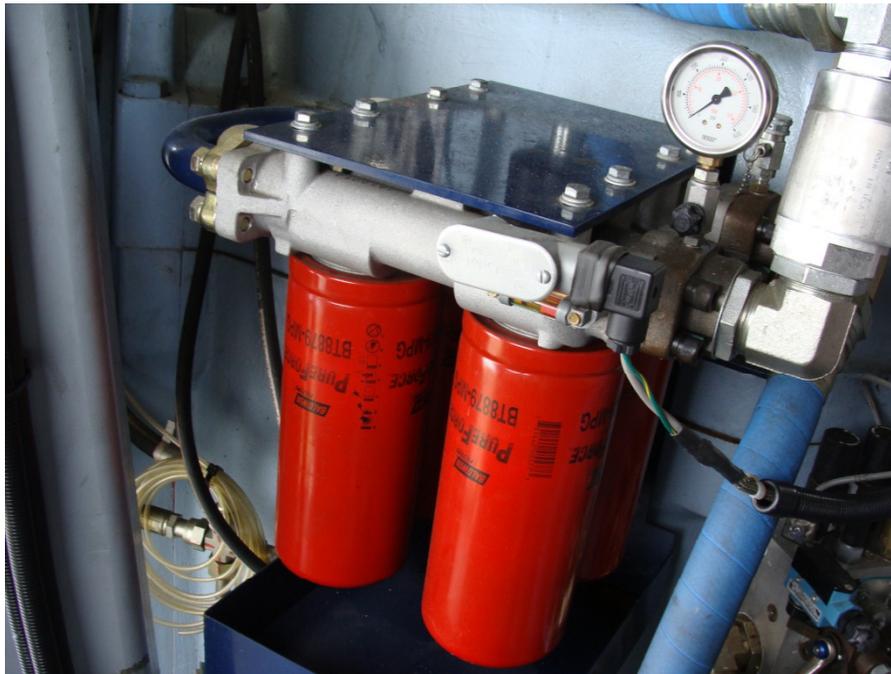
## Inline Filters

Typically Installed in Cooling Circuit  
High Flow – Low Surface Area

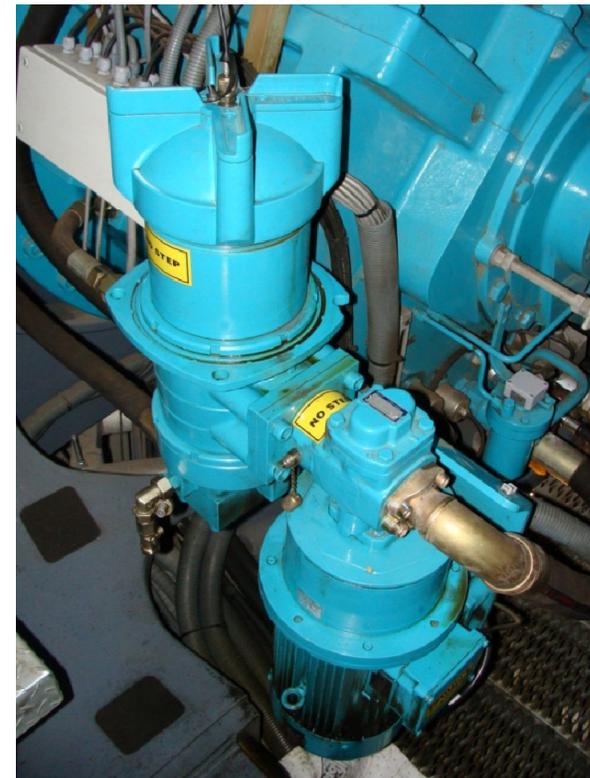
Typically 10µm

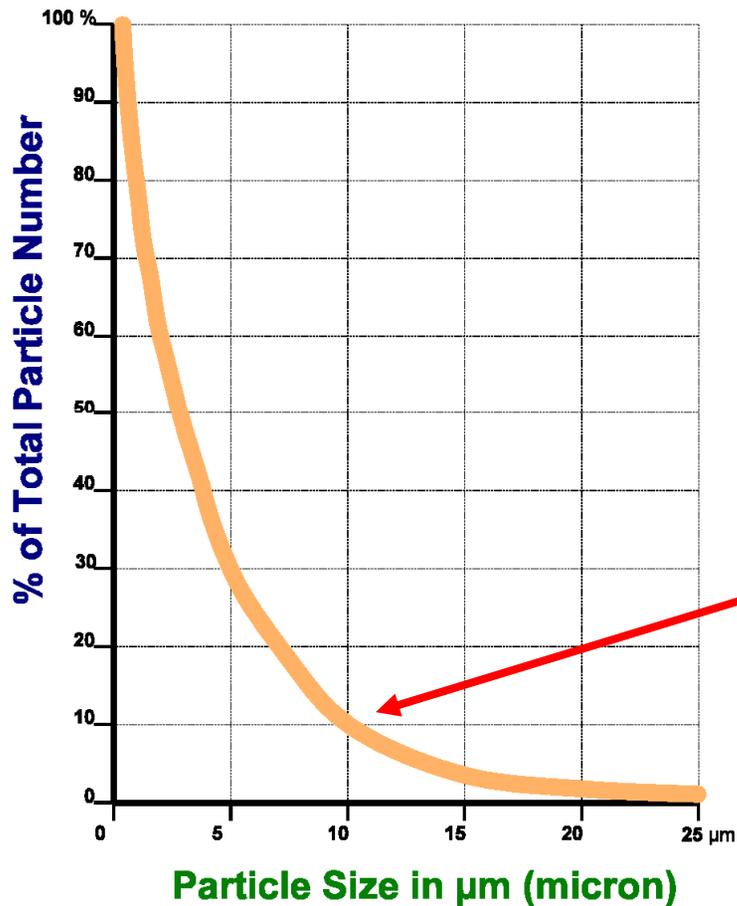
## Particle Size Distribution

On average, 10 $\mu$ m particles only comprise 10% of the total particle population

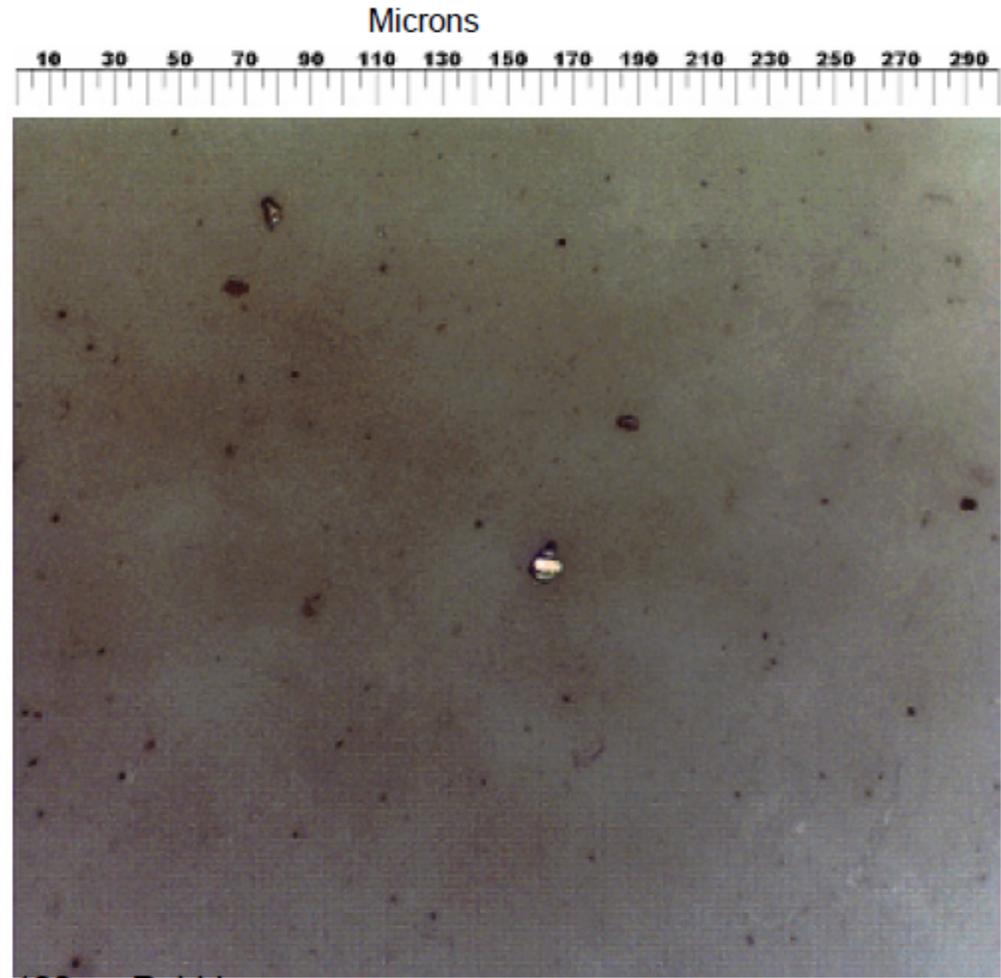
# Inline Filter Performance

**Turbine:**  
**>1 MW**

**Year Online:**  
**2009**

**ISO Code:**  
**20/18/15**

100x Rubbing wear.

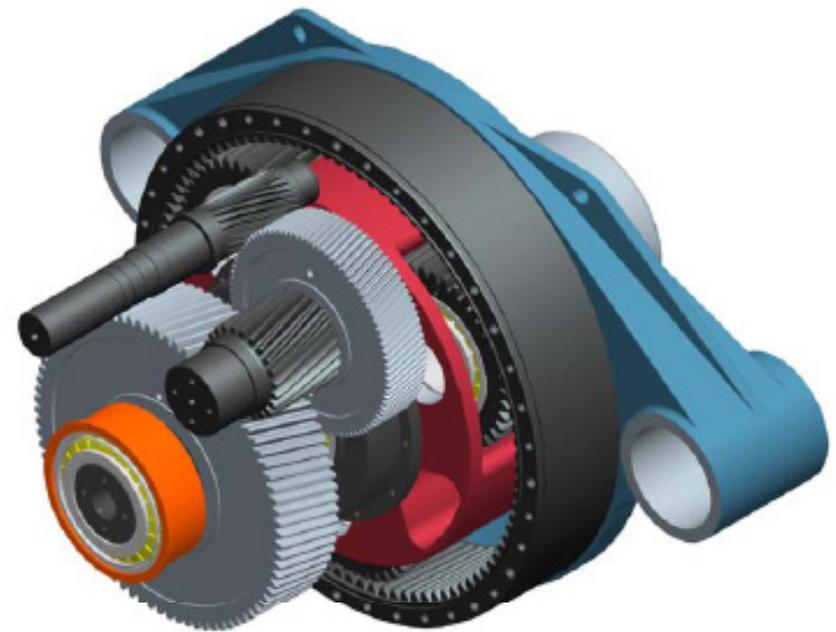
# Is it a Gearbox or Dirtbox?

Filter Rating	ISO Code	Dirt (lbs)	50 lb Bags
10 $\mu\text{m}$	20/18/15	1,065	21.3
3 $\mu\text{m}$	14/12/9	14	0.28

Oil Cooler Circuit  
32 gpm flow rate  
1 Year of Operation

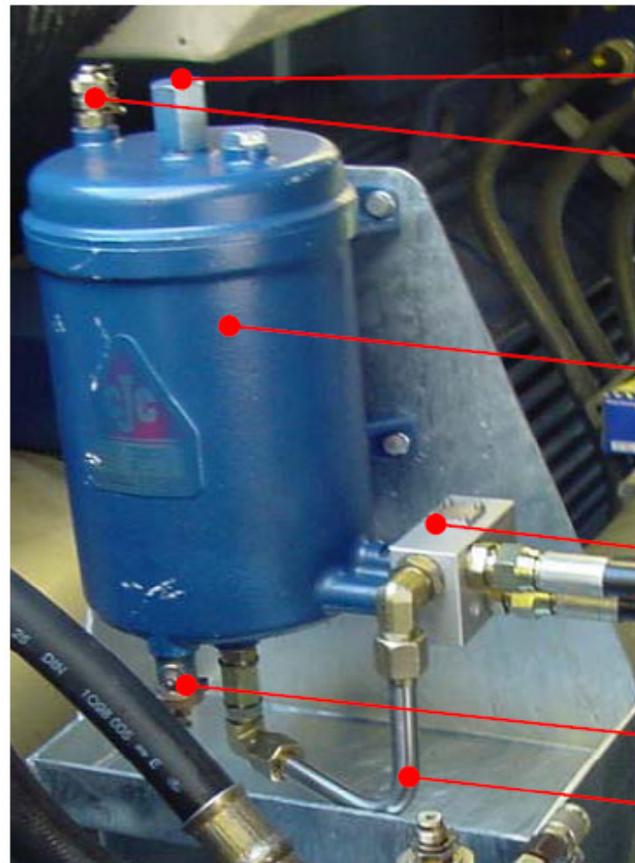
# Bypass Filters

Typically 3-10 $\mu$ m

Only functions when  
the oil cooler circuit is  
operating

Consumes energy

Acorn nut, HDU 15/25

Meter connection

CCJ by-pass filter housing

Valve block

Drain cock

16mm pipe

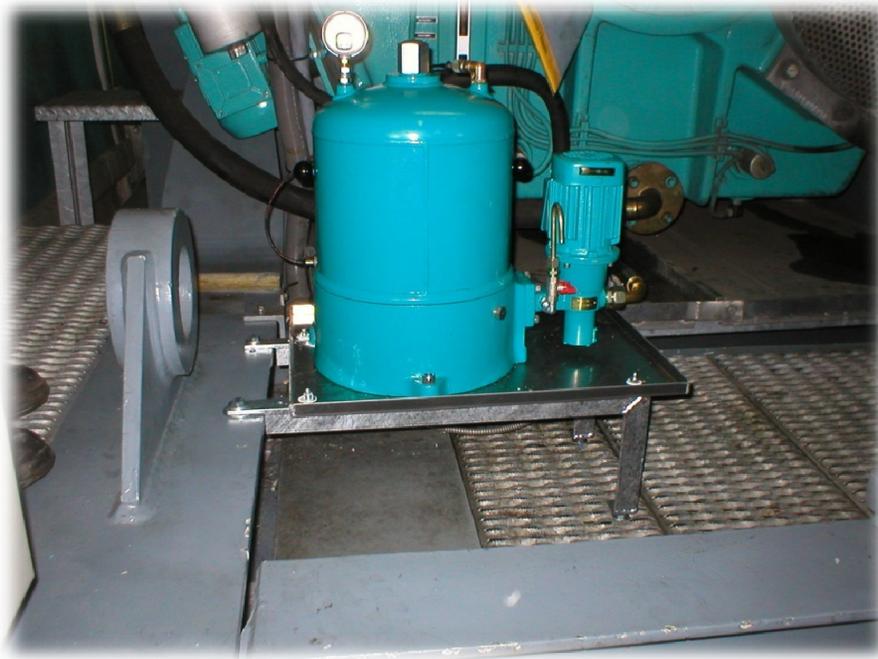
## Offline Filters

Low Flow – High Surface Area

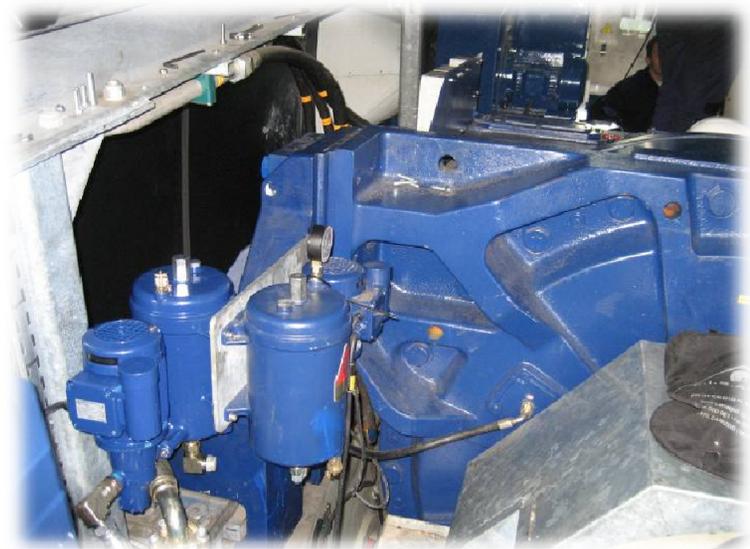
Typically 3 $\mu$ m  
Removes Particles, Water,  
and Varnish

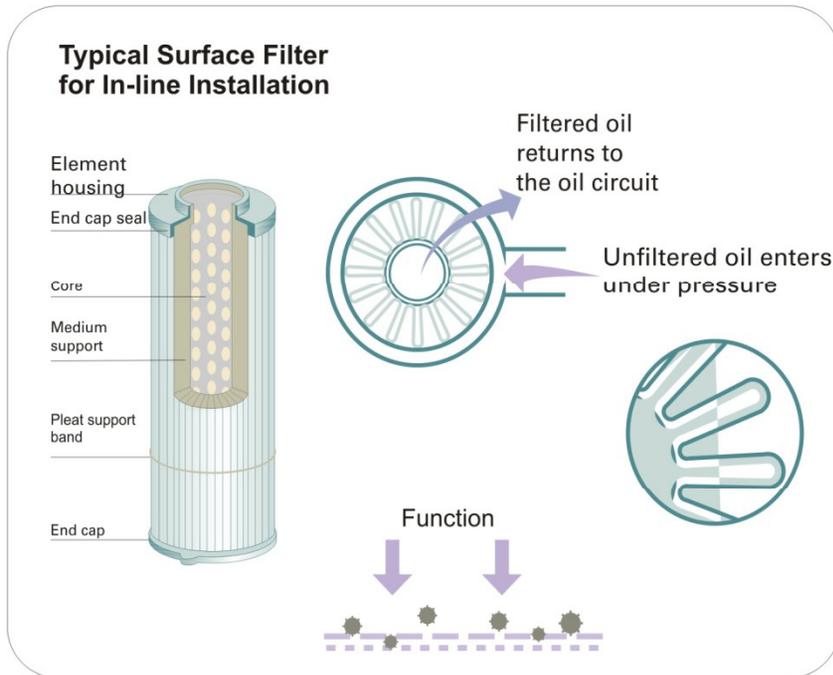
### Surface Filter

## Filtration Comparison, Surface vs. Depth

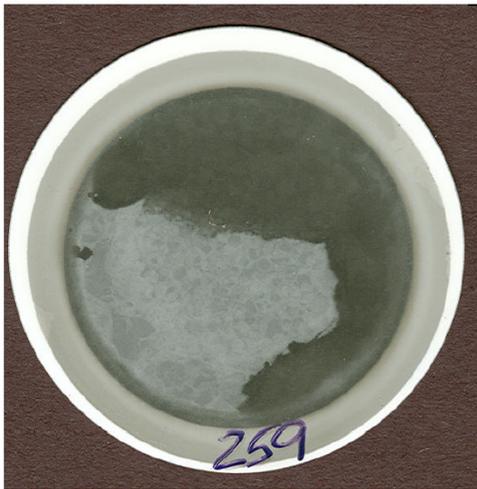
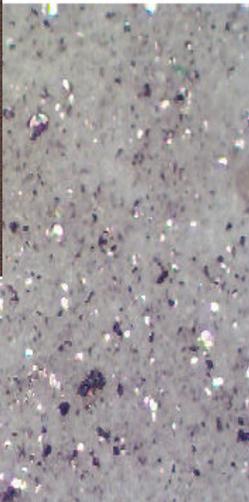
<1 MW Wind Turbine  
24 Hours

x100 Contami

**Before Retrofit:**  
ISO 25/24/19

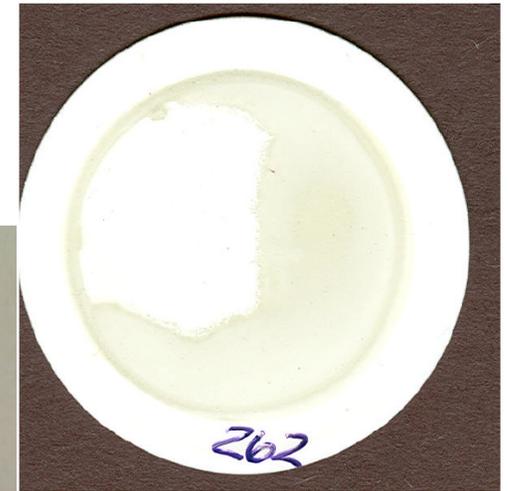
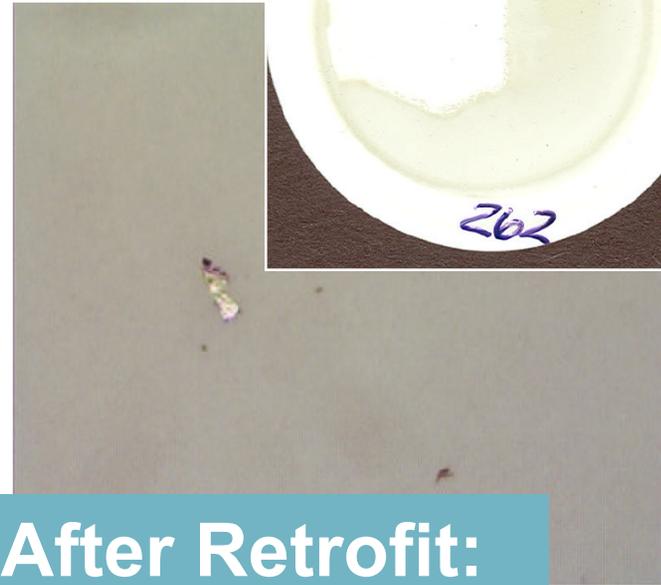
**After Retrofit:**  
ISO 18/16/13

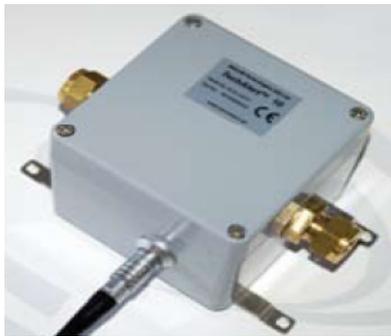
**Method**  
Eddy Current

**Detection**  
≥50 µm

**Communication**  
RS232

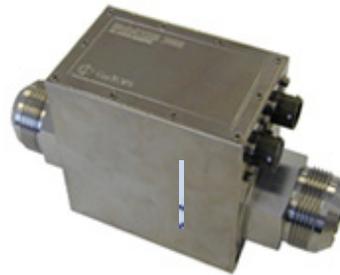
**Method**  
Eddy Current

**Detection**  
≥100 µm

**Communication**  
Digital Output

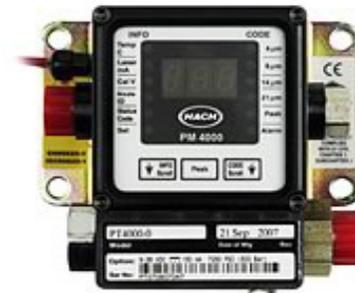
**Method**  
Laser

**Detection**  
≥ 4 µm

**Communication**  
GPRS Modem,  
RS485 Network,  
PLC, RS232

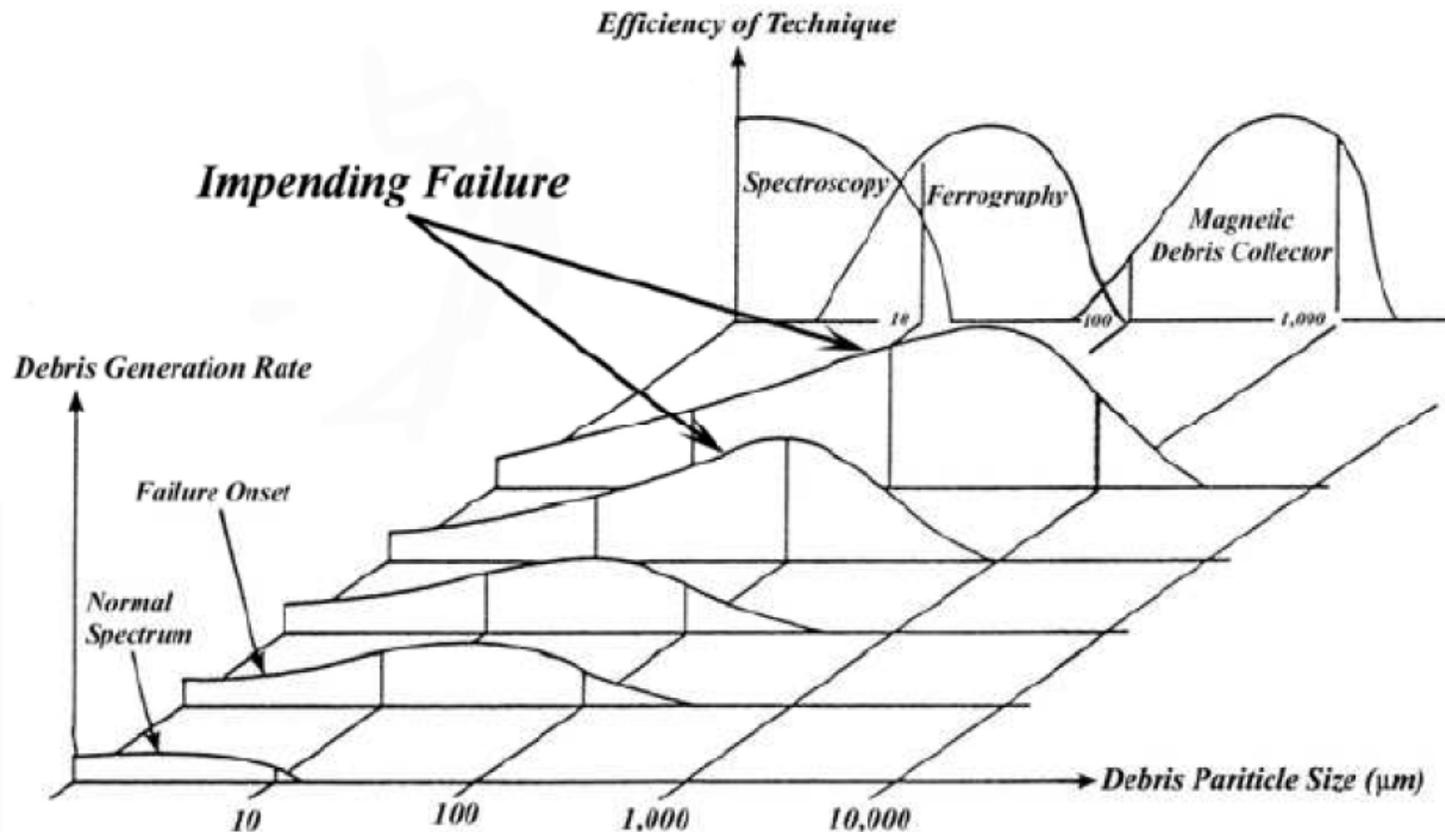
# Small Particles Show Up First

Ref: Raadnui, S., Magnetic Chip Detector Wear Particle Analysis

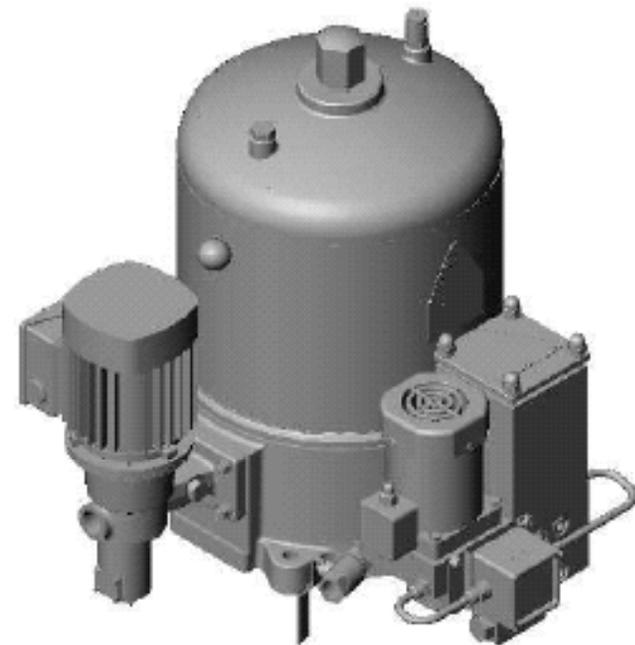
# Case Study – Laser Particle Counter

Measures oil cleanliness according to ISO 4406;  
4,6, 14  $\mu\text{m}$  and 21  $\mu\text{m}$

Installed with Offline Filter System  
(connected to measure before off-line filter from  
most dirty point in gearbox)

Not sensitive to air

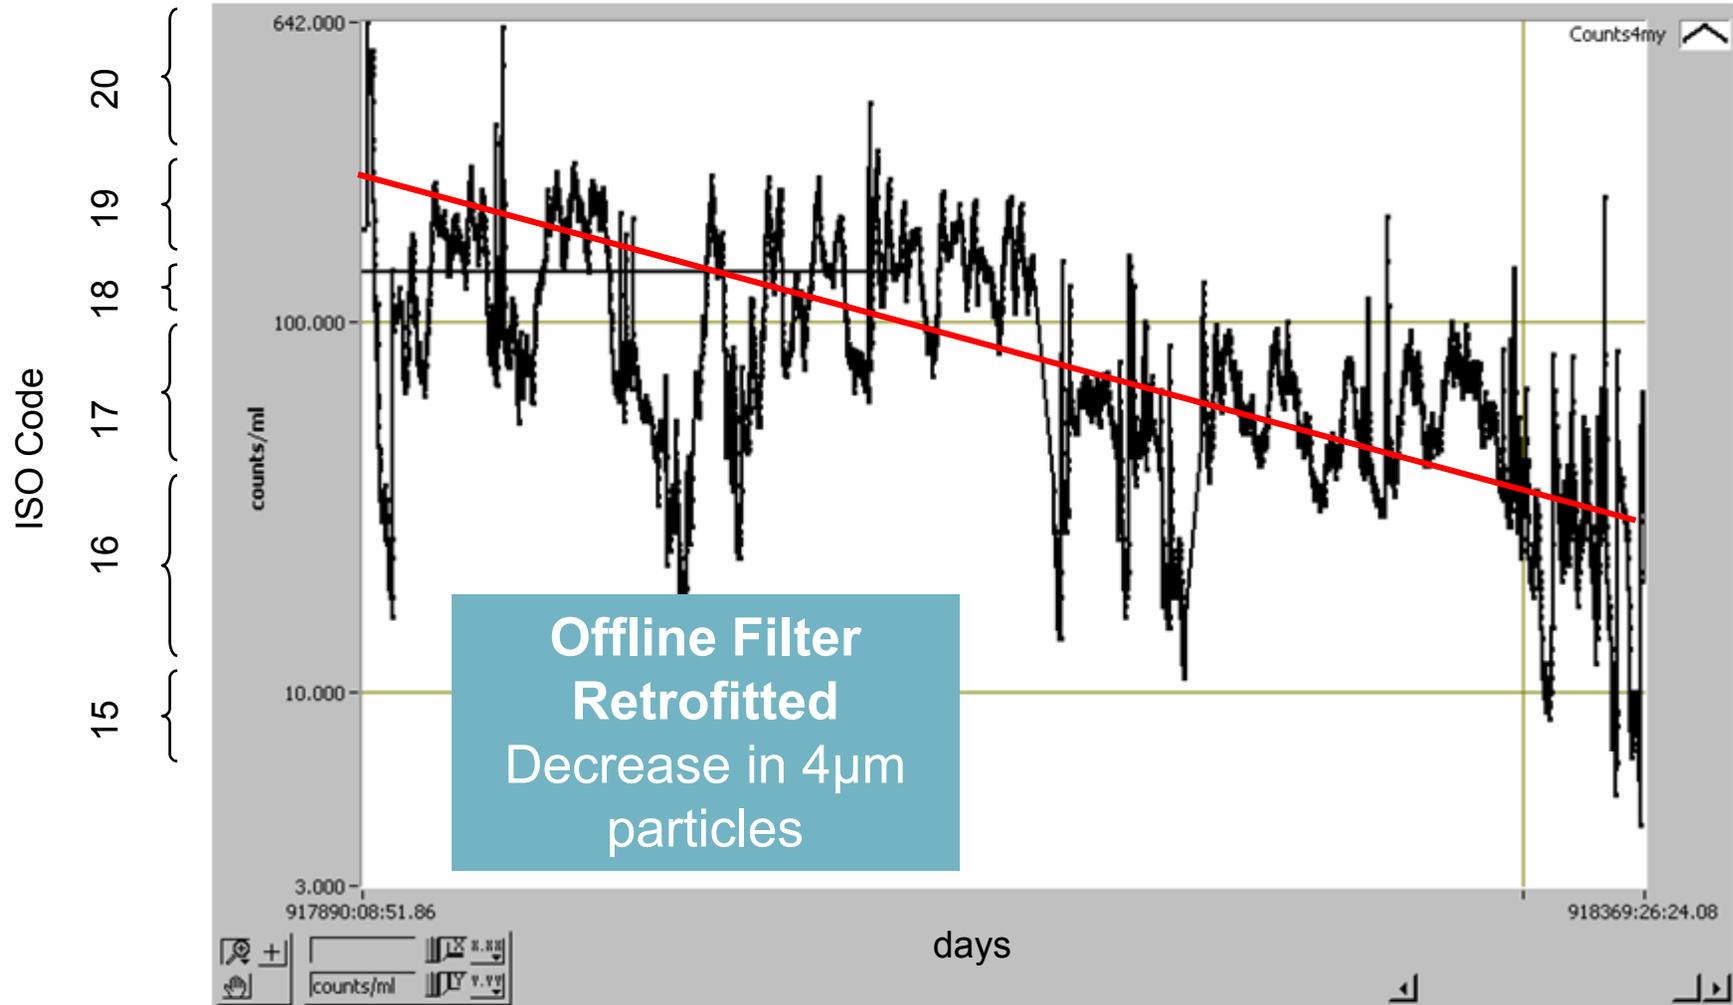
Figure 10 Slow decrease of 4 micron particles after CJC offline filter has been retrofitted. The scale is logarithmic. The abscissa is in days.

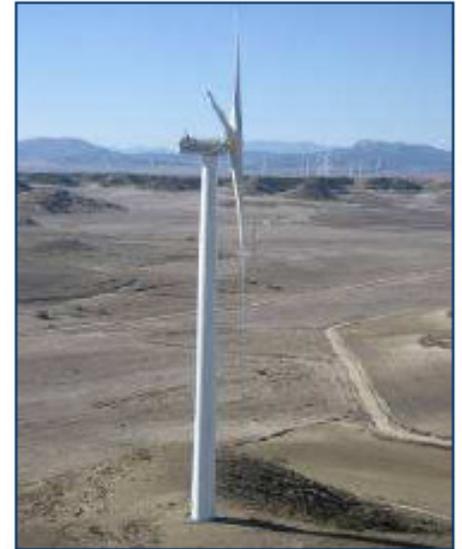
Nordex N62/1300 with CJC On-line particle monitor

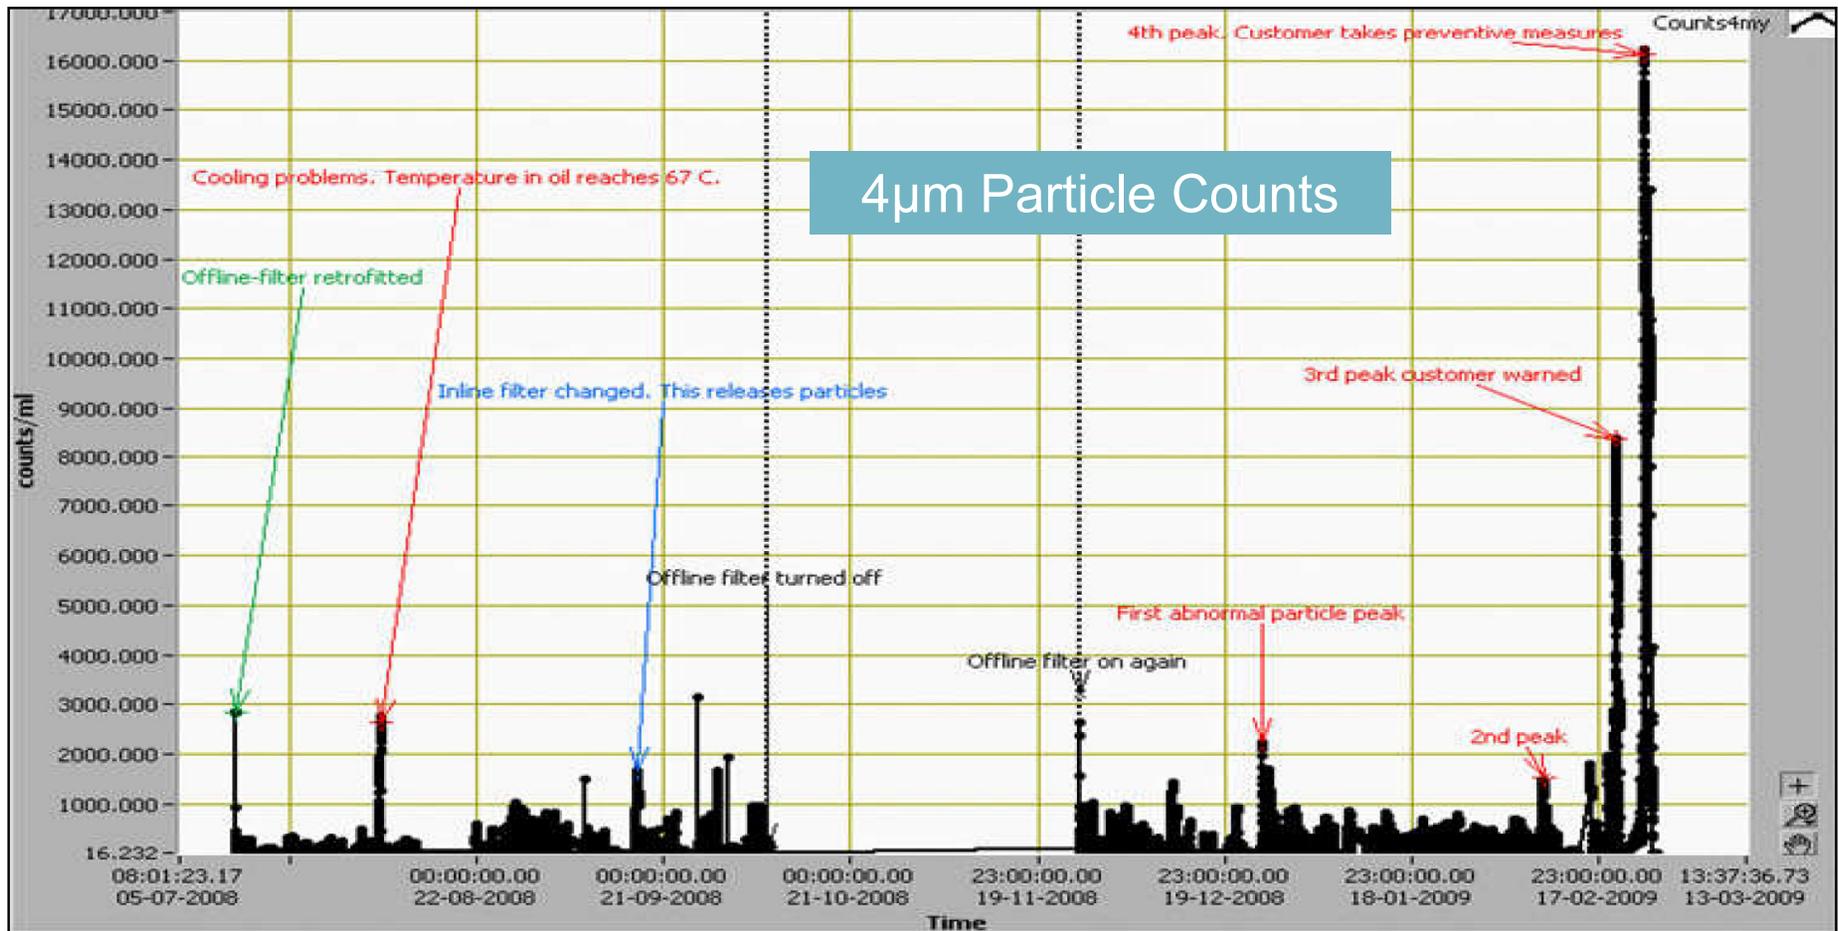
### RESULTS

The customer was informed and warned 6 days before the turbine was stopped for preventive maintenance during which time the gearbox damage was confirmed after a visual inspection.

At the time when CJC Particle Counter indicated the failing gearbox and imminent breakdown there was no other SCADA warning. The gearbox was replaced and repaired within a planned turbine stop.

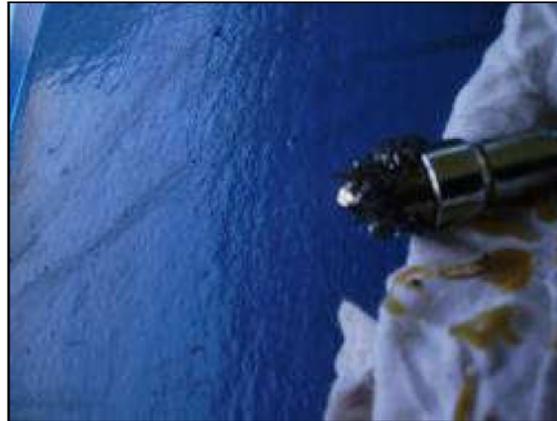
**Picture 1**

Wear particles found during Service stop and visual Gearbox inspection. The customer reconfirmed Gearbox damage after inspection and finding a lot of particles in the Gearbox.

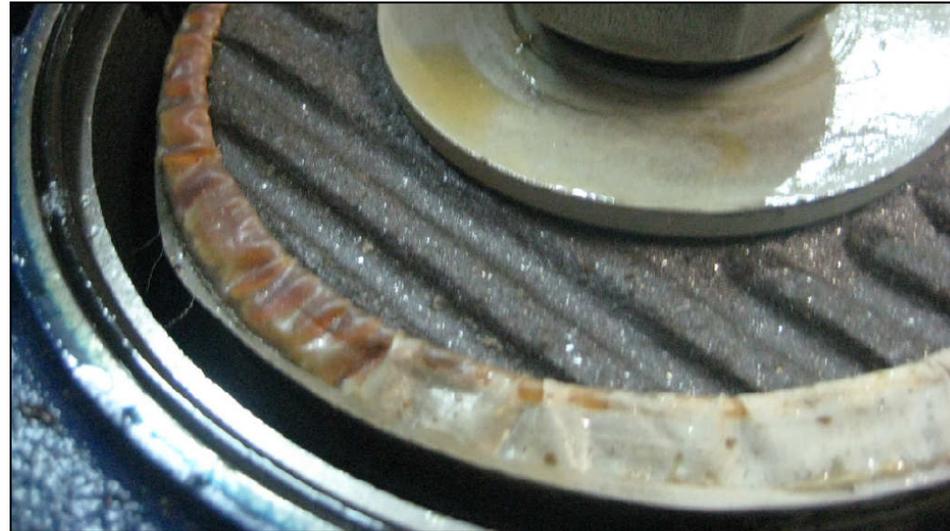
**Picture 6**

## Case Study – Laser Particle Counter 1.3 MW Wind Turbine

Finding of wear particles on the surface of the off-line filter insert that was removed after the gearbox damage was confirmed, confirm that the Off-line filter worked perfectly filtering out a hugh amount of wear particles.

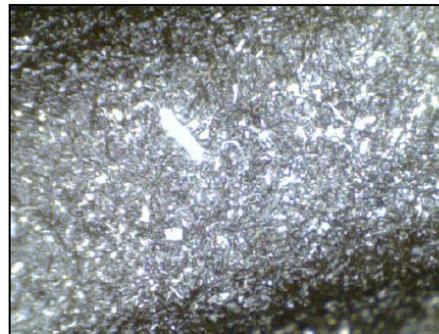
**Picture 7**

The foto of the zoomed in off-line filter surface shows metal wear particles of different sizes and forms. It can be easily seen that more than 70% of the surface it covered with wear particles.

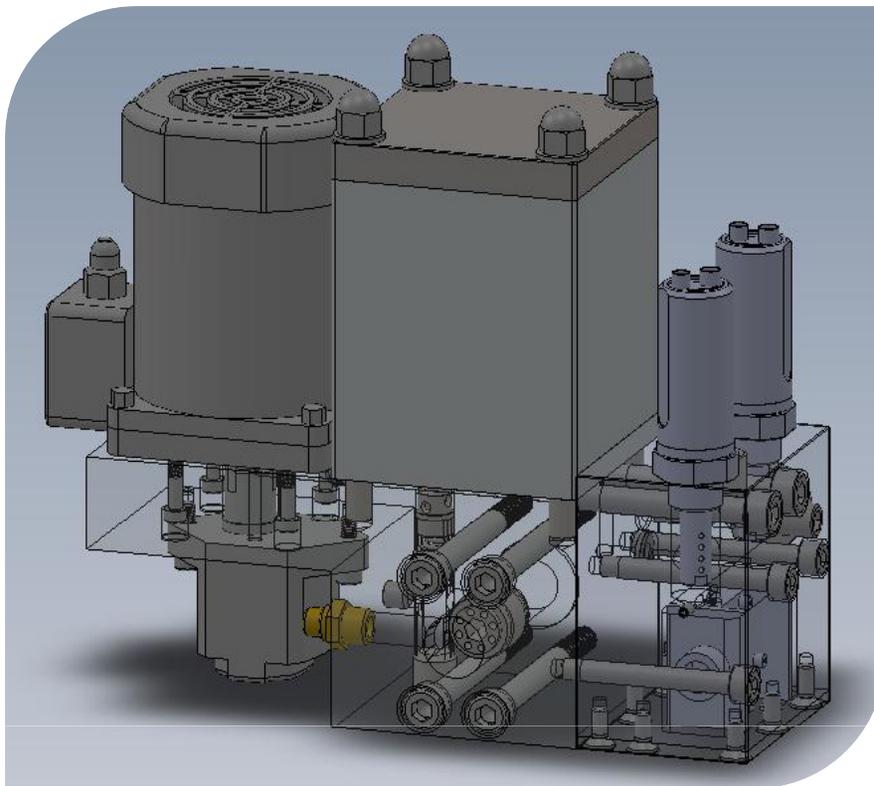
### A Holistic Approach to Oil Condition Monitoring

- ✓ Particle Counter
- ✓ Water Sensor
- ✓ Viscosity Sensor
- ✓ Oxidation Sensor

Compact Design
